Post-Facto Analysis of a Near-Blackout Event¹

ABSTRACT

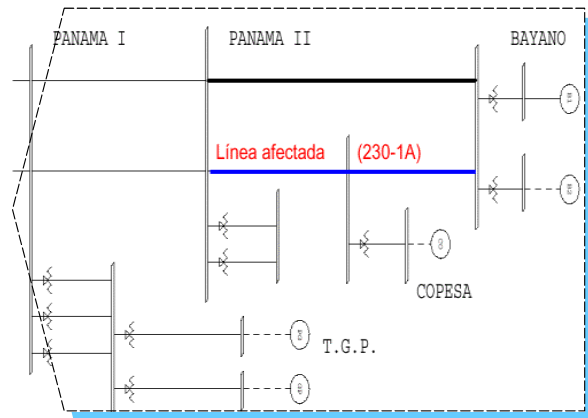
Figure 1.a Line affected by lightning

After a lightning strike on the PANAMA II - Bayano transmission line (Figure 1.a), the phase C conductor remains hanged on a metallic pole, which turns the fault into a permanent short-circuit. Line protections work correctly and open the line at both ends. Due to the rapidly changing readings, the state estimator's execution is suspended.

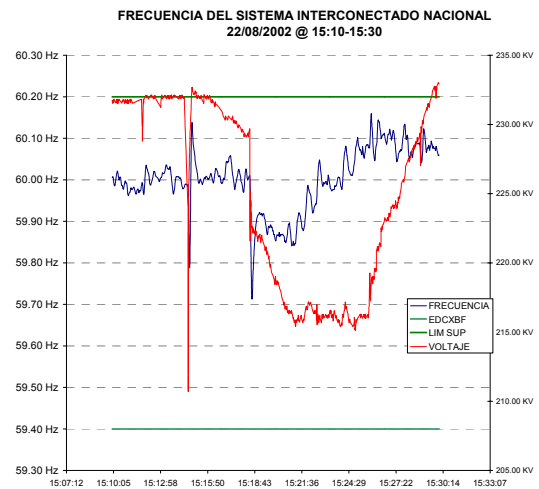
Figure 2 Frequency excursions during the event

The primary regulation responds immediately and the system's frequency goes back to normal (Figure 2).

Since no generators are available to supply reactive power to the load center, the distribution companies are alerted of the situation and the system operator asks them to shed approximately 20 MW each. As shown in Figure 2, the load reduction helped the frequency but didn't solve the voltage problem. Therefore, the system operator asked for additional load shedding but the distribution companies did not honor the request.

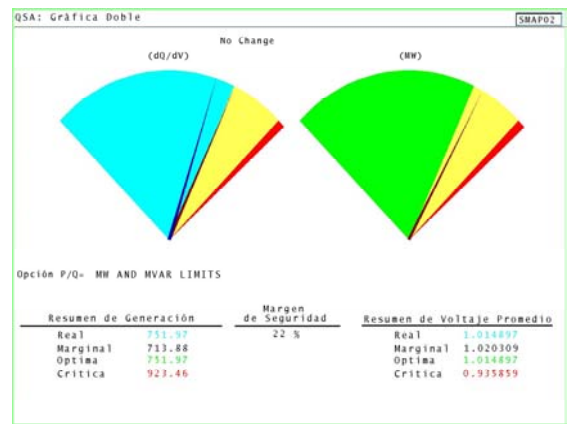
Case 2 was built from data retrieved immediately after the tripping of the line 230-2A and the loss of COPESA generation. The distance to steady-state instability is depicted in Figure 4 (curve P-V not shown).

At that time, the network was relatively close to the security margin but the disturbance was in progress and the transmission grid was entering the “alert” zone (shown on the speedometer chart with yellow color).

It’s important to note, however, that although the stability reserve (distance to instability) was acceptable, the operating point was slowly moving towards instability, i.e., the system’s critical state (shown in red). Note, also, that the total reactive demand had increased to 237.5 MVARs.

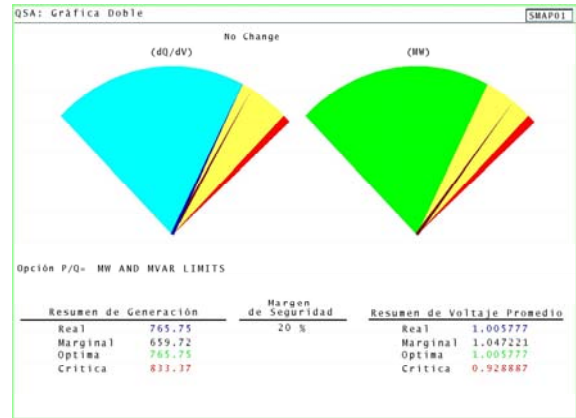
Figure 5.a

In the third and last case of our analysis, the two PANAM units that had actually tripped during the event were outaged from the base case. As clearly shown in Figure 5.a, this caused the system to quickly approach the steady-state stability limit. The total reactive demand increased to 250.65 MVARs.

These results are fully consistent with the real-time readings shown in the event’s chronology, where the loss of the third PANAM unit caused the voltage profile to reach near-critical values.
